Sample Name USB Type C Receptacle,Horizontal,Mid Mount,SMT,IP67,For Power Charging Only  
Type USB4715-GF-A  
Sample Receiving State Normal  
Sample Received Date Jun. 7, 2022  
Testing Period Jun. 7, 2022-Jun. 13, 2022

No.	Test Item
1	IP6X

## Test Report

**Test Item: IP6X****1. Test Equipment**

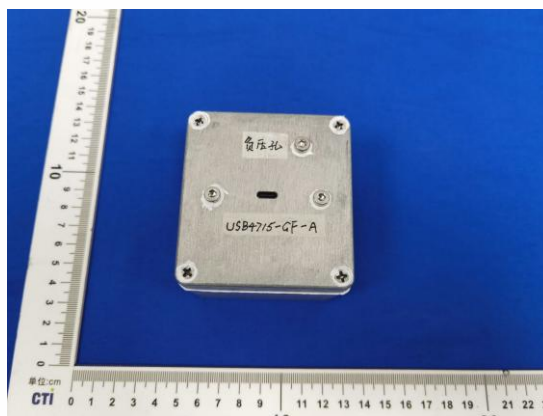
Sample No.	Sample Name	Type	Quantity
A2220226485101001	USB Type C Receptacle,Horizontal,Mid Mount,SMT,IP67,For Power Charging Only	USB4715-GF-A	1pc

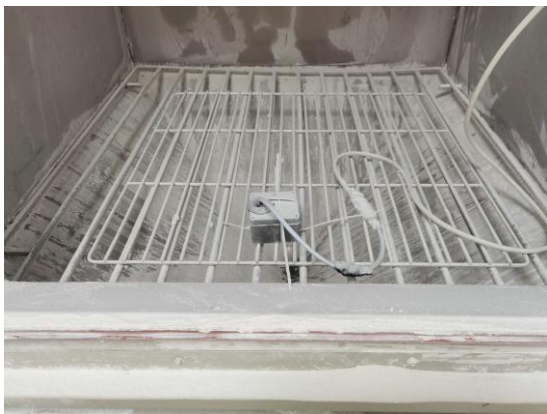
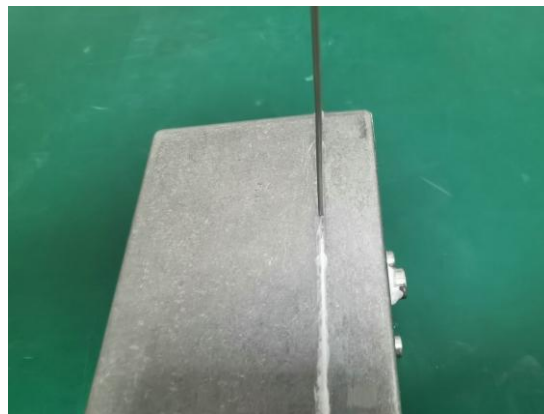
Use a test probe with a diameter of 1mm to probe the gap part of the sample with a force of 1N.

Put the sample in a negative pressure state, the pumping rate is 40-60 times the volume of the shell per hour, and the pressure difference between the pressure in the shell and the atmospheric pressure is less than 2kPa, and the test is continuously performed for 2h in the dust-proof test box.

Sample No.	Criterion	Test result (Visual inspection)	Conclusion
A2220226485101001	The test probe cannot penetrate into the sample, and there is no dust inside the sample.	The test probe cannot penetrate into the sample, and there is no dust inside the sample.	Pass
Remarks: The basis for judgment is provided by the customer.
